INDOOR AIR QUALITY REASSESSMENT

**Nathaniel Morton Elementary School
6 Lincoln Street
Plymouth, Massachusetts**

Prepared by:
Massachusetts Department of Public Health
Bureau of Environmental Health Assessment
Emergency Response/Indoor Air Quality Program
May, 2001

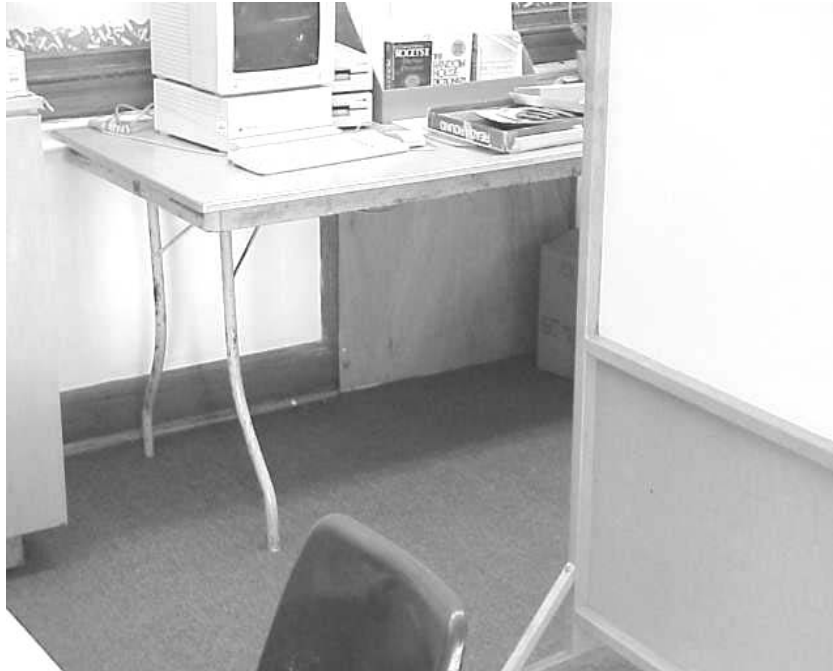
Picture 1

All abandoned natural/gravity feed exhaust and supply vents were sealed with plywood (see Picture 1).

Sealed Exhaust Vent

- 5. Ensure abandoned natural/gravity feed exhaust and supply vents are properly sealed to eliminate pathways for movement of particulates into occupied areas.**

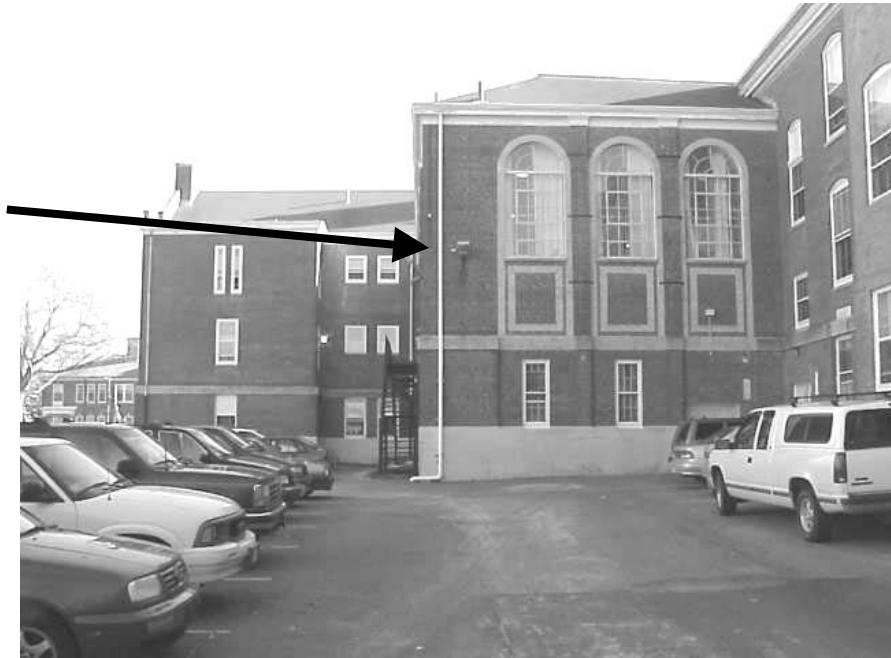
Picture 2

In addition to these recommendations, school officials have repaired damaged downspouts (see Picture 2) to ensure proper drainage.

Newly Installed Rain Downspout
